5/037/0121  
Energy Fuels Resources (USA) Inc.  
225 Union Blvd. Suite 600  
Lakewood, CO, US, 80228  
303-974-2140  
www.energyfuels.com

**RE: MODIFICATION to Stream Alteration Permit Application 15-99-01SA**

# Stream Alteration Permit Application Modification 1

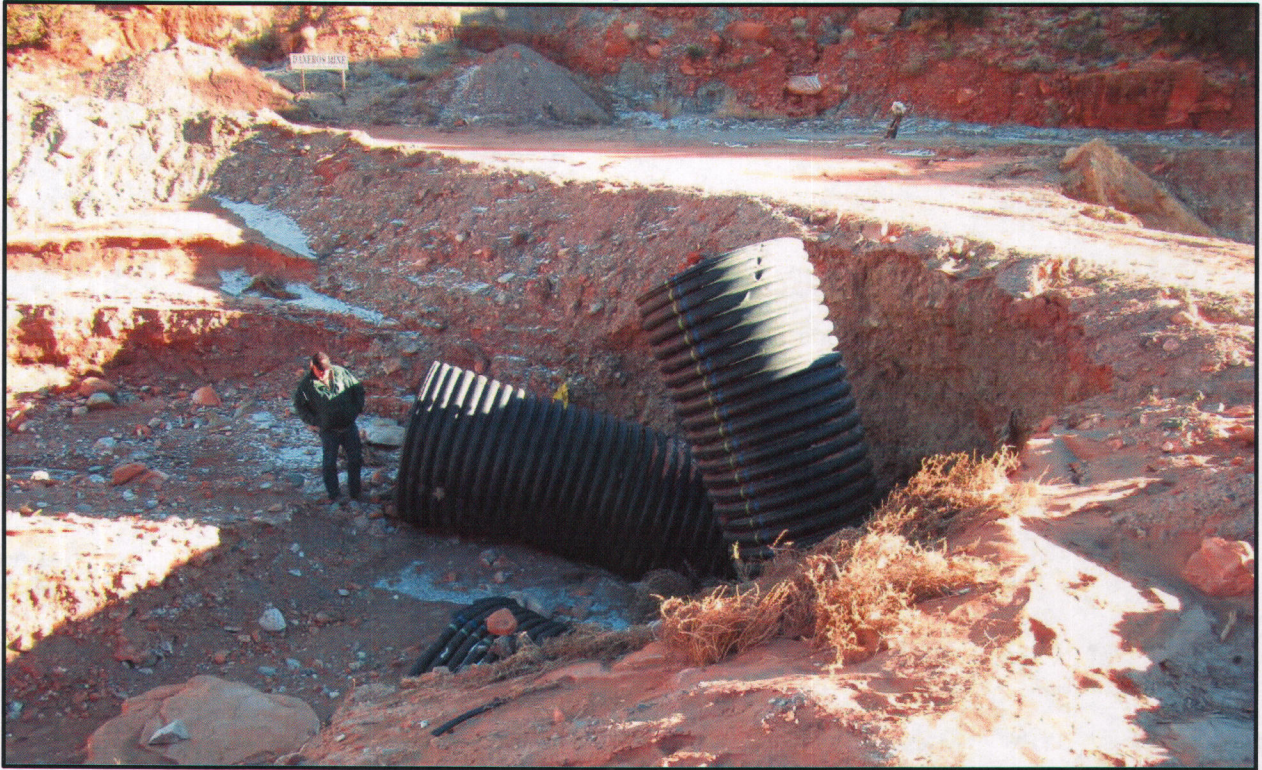
Three 60-inch culverts were installed at the Daneros Mine in 2010 under Stream Alteration Permit Number 10-99-01SA. The culverts are located within Bullseye Canyon and carry flow from the watershed northeast of the mine under the county road where it continues to flow southwest in the canyon as shown on Map 2. During the most recent storm, all three culverts were damaged beyond repair and must be removed and replaced. See Photograph 1 below. The culverts were sized to pass a 100 year, 24 hour storm event and based on post-storm site conditions, it is estimated that the flash flood exceeded the design storm event. The existing 3 culverts are 60-inch HDPE. Photograph 2 shows the culverts downstream of the road. The road constructed in 2010 was 24-feet wide and more than half of that span was scoured away during the recent storms, exposing a significant length of the culverts on the downstream side.

**Photograph 1 Culverts on the Upstream side of the Road (12/2015)**

Energy Fuels proposes to remove and stockpile the remaining road bed material, then remove the culverts and replace them with 8-foot corrugated steel culverts as shown on Map 4. We anticipate that these replacement culverts will be more durable and will be capable of passing larger storm events. Once the new culverts are placed, we propose to re-construct the road to an approximate width of 24-feet. The center culvert will be placed 6-inches lower than the other two to help maintain an active water course. The equipment used to replace the culverts will be the same as the equipment proposed for use in the November stream alteration permit application. The disturbance area associated with replacement of the culverts will be similar to what was disturbed during their original placement. That area was surveyed for cultural resources in 2008 and the report was provided to DWR as part of the application for Stream Alteration Permit Number 10-99-01SA. No sites were found that were considered potentially eligible for the National Register of Historic Places.

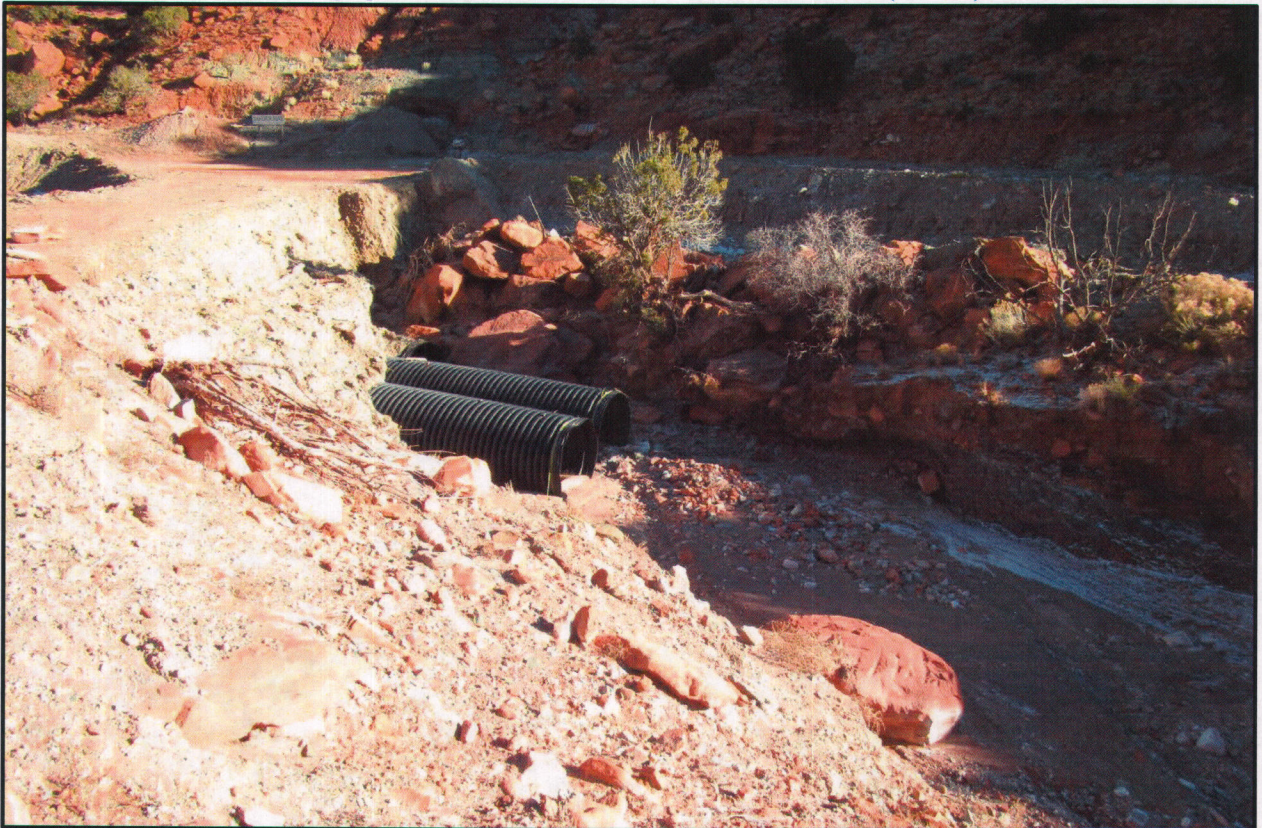
**Photograph 2 Culverts on the Downstream side of the Road (12/2015)**

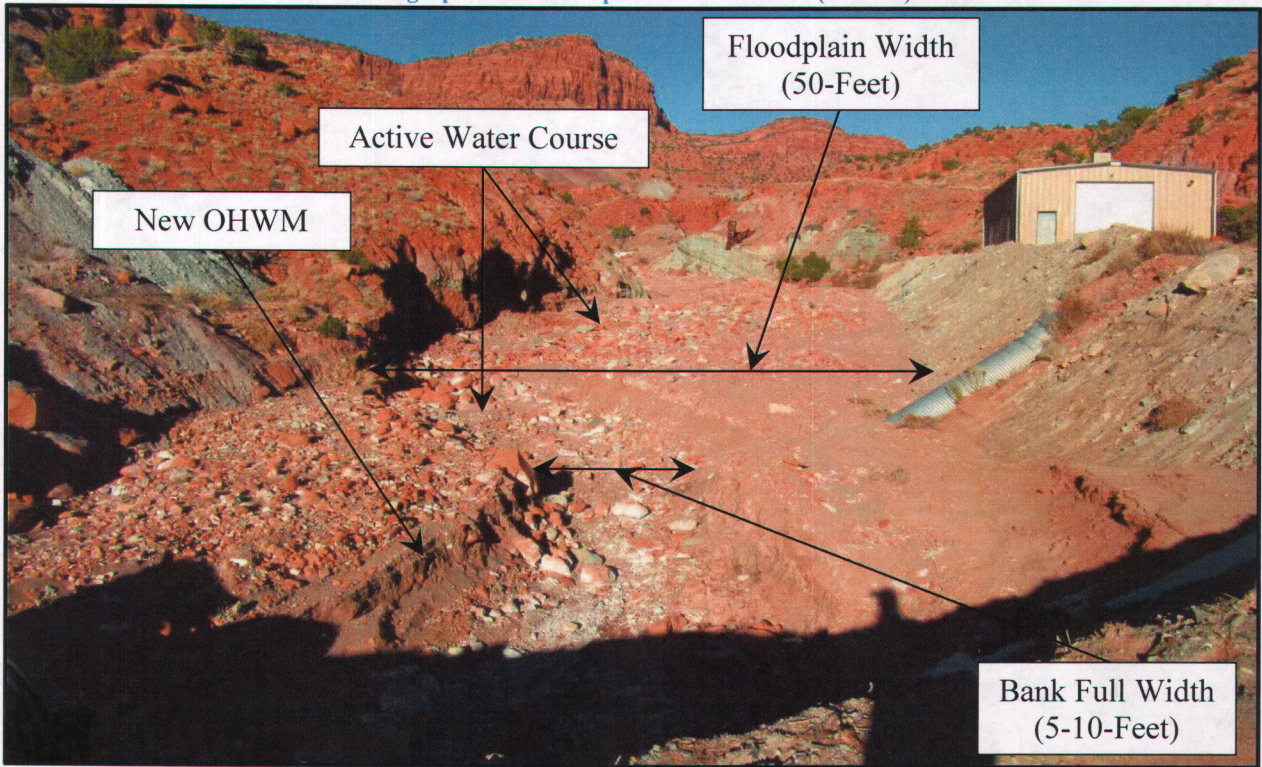
Photographs 3, 4 and 5 below were taken at the same vantage point in December 2015, July 2015 and June 2013 respectively. This series of photographs show the channel just upstream of the road prior to, in between, and after the series of large storms that passed through the area in the summer and fall of 2015. The photographs are marked to show the active water course and the estimated OHWM. The most recent storm adjusted the active water course closer to its previous alignment, as shown in Photographs 3 and 5. While that helped to prevent immediate damage to the fill material supporting the mine shop, the work proposed in the November application still needs to be completed to protect the shop from future damage.

Photograph 3 Channel Upstream of the Road (12/2015)

Maps 2, 3 and 4 incorporate the requested information. Photograph 3 was also annotated to include this information. The impacts to the area below the OHWM include:

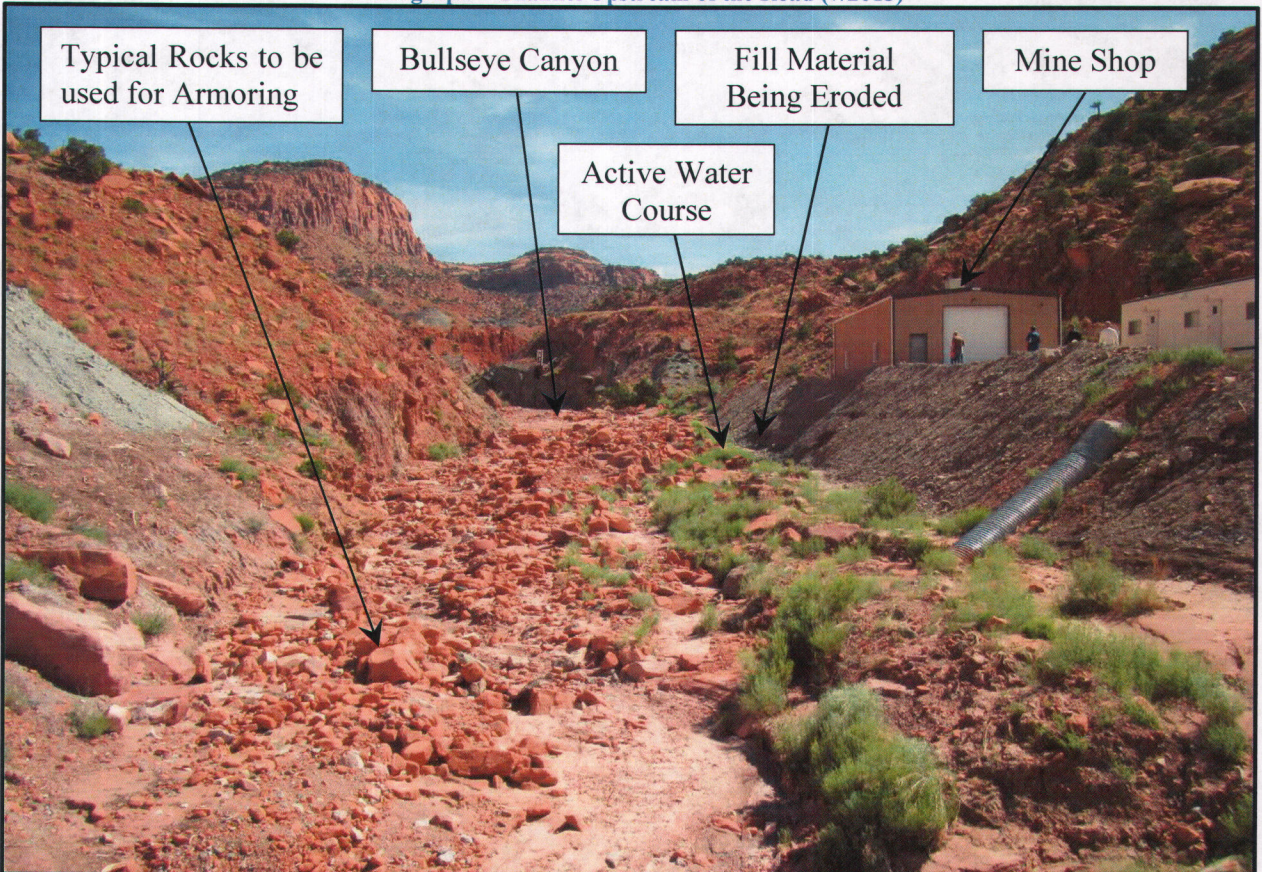
Photograph 4 Channel Upstream of the Road (7/2015)

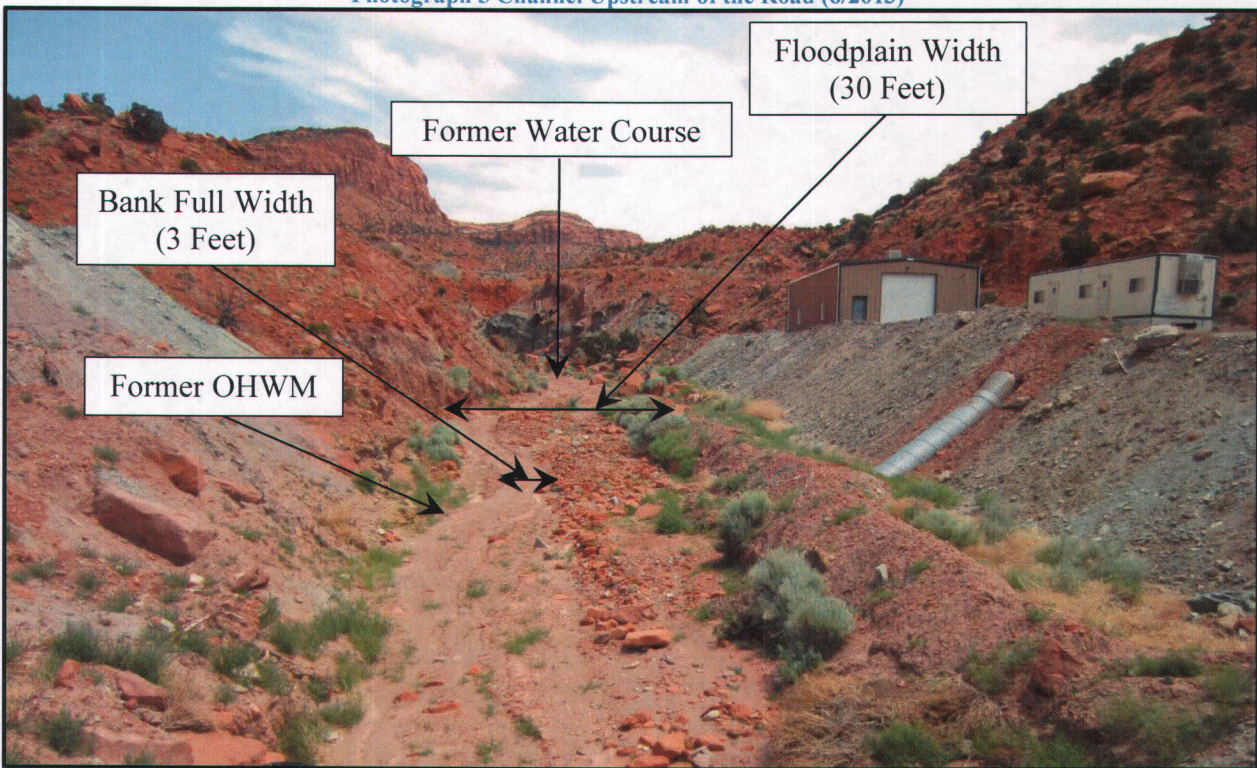
Photograph 5 Channel Upstream of the Road (6/2013)

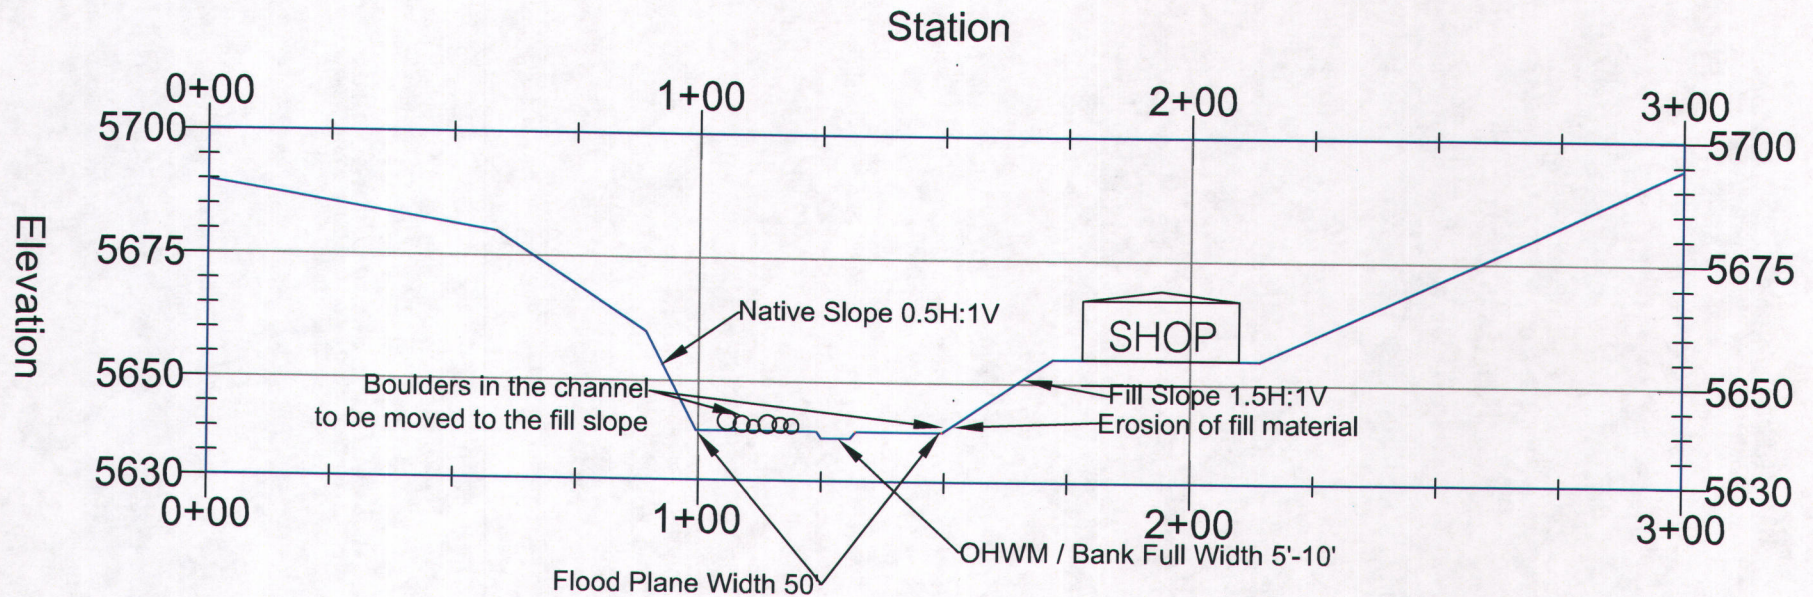
# Bullseye Canyon Cross Section A-A'

Map 3 was revised to incorporate the requested information. Photographs 3 and 5 were annotated to include this information. Map 4 was provided to show the proposed culverts.

The active water course, or area below the OHWM, upstream of the culverts will be cleaned out of large material so that it can pass normal storm events. The removed material will be utilized to armor and support the fill material which is located on the western edge of the floodplain. No fill will be placed below the OHWM. The reach length below bank full that will be impacted by this activity is approximately 275 feet.
